WINTERBOURNE MEDIEVAL BARN

WMB8 – Conservation Statement

Winterbourne Court Farm Barn

CONSERVATION STATEMENT

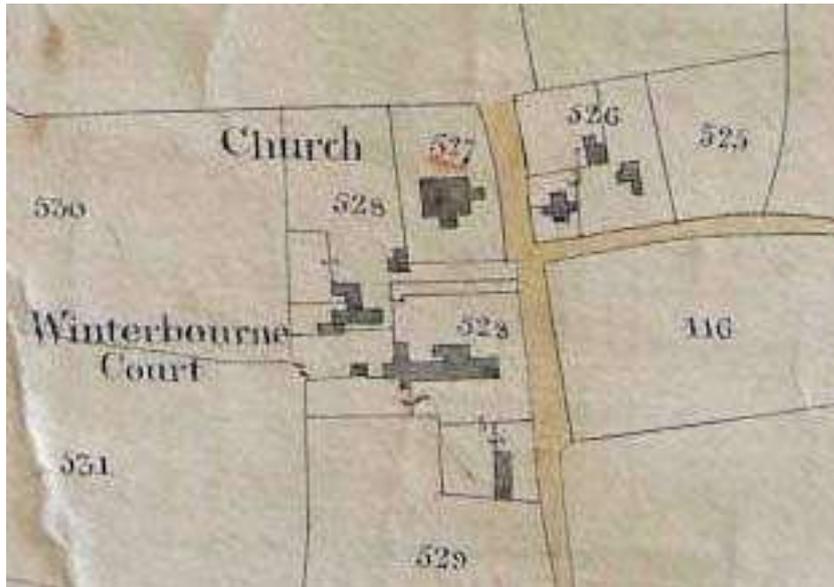
The Winterbourne group as shown on the 1844 Tithe map (thanks to Frenchay Museum on-line archives)

4.7 Between the barn and the church is another range, again not shown on the 1844 map and in place, though with a slimmer footprint, in 1881-2. It retained this earlier footprint until at least the mid 1930's and has since been rebuilt with a deeper plan.

4.8 East of the church is a group of four cottages of similar style: they are all shown on the 1844 map (and noted at that time as occupied by Robert Stockton, Charles Offer, Thomas Skipton and John Escott). Two are listed: **no 4 Church Cottages (grade II)** and the cottage furthest east (**Rose Cottage: also grade II**). They are picturesque stone buildings with details in Tudor style. No 4 is dated 1829 and it is likely that Rose Cottage is of similar date. Their list descriptions are as follows:

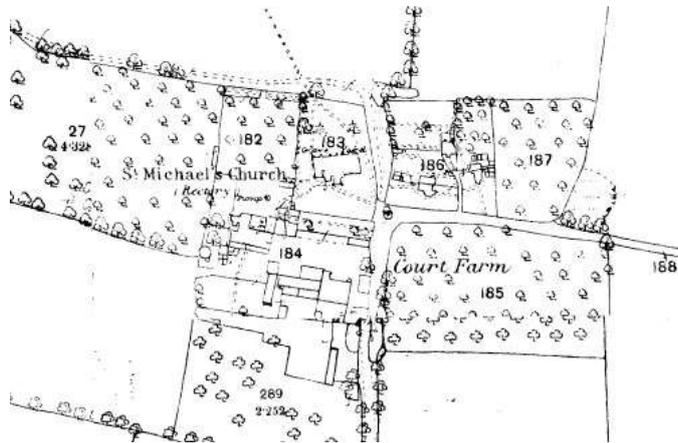
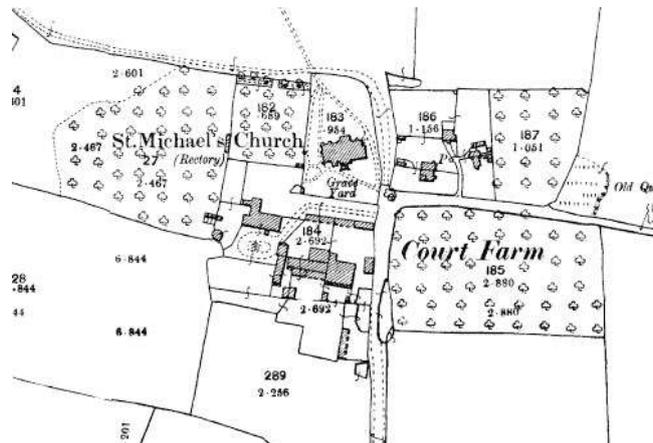
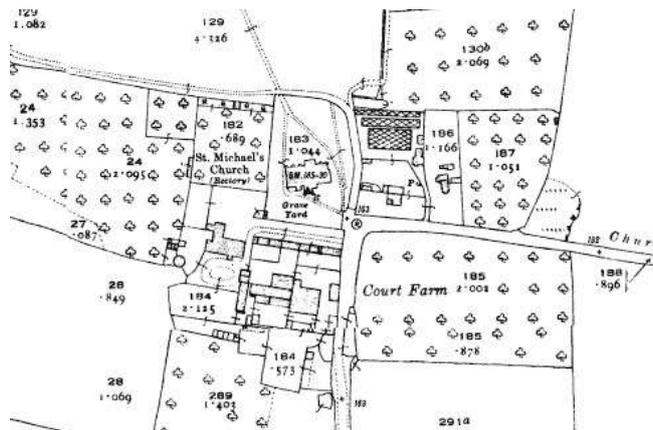
Historic Ordnance
Survey 25" maps:
Top: 1881-2
1st Edn.

Centre:
2nd Edn.

Bottom: Edn.
of
1935
