# **WINTERBOURNE MEDIEVAL BARN**

**HLF Bid Reference HG-15-04570**

**Supporting Information**

**WMB1 – History and Heritage**

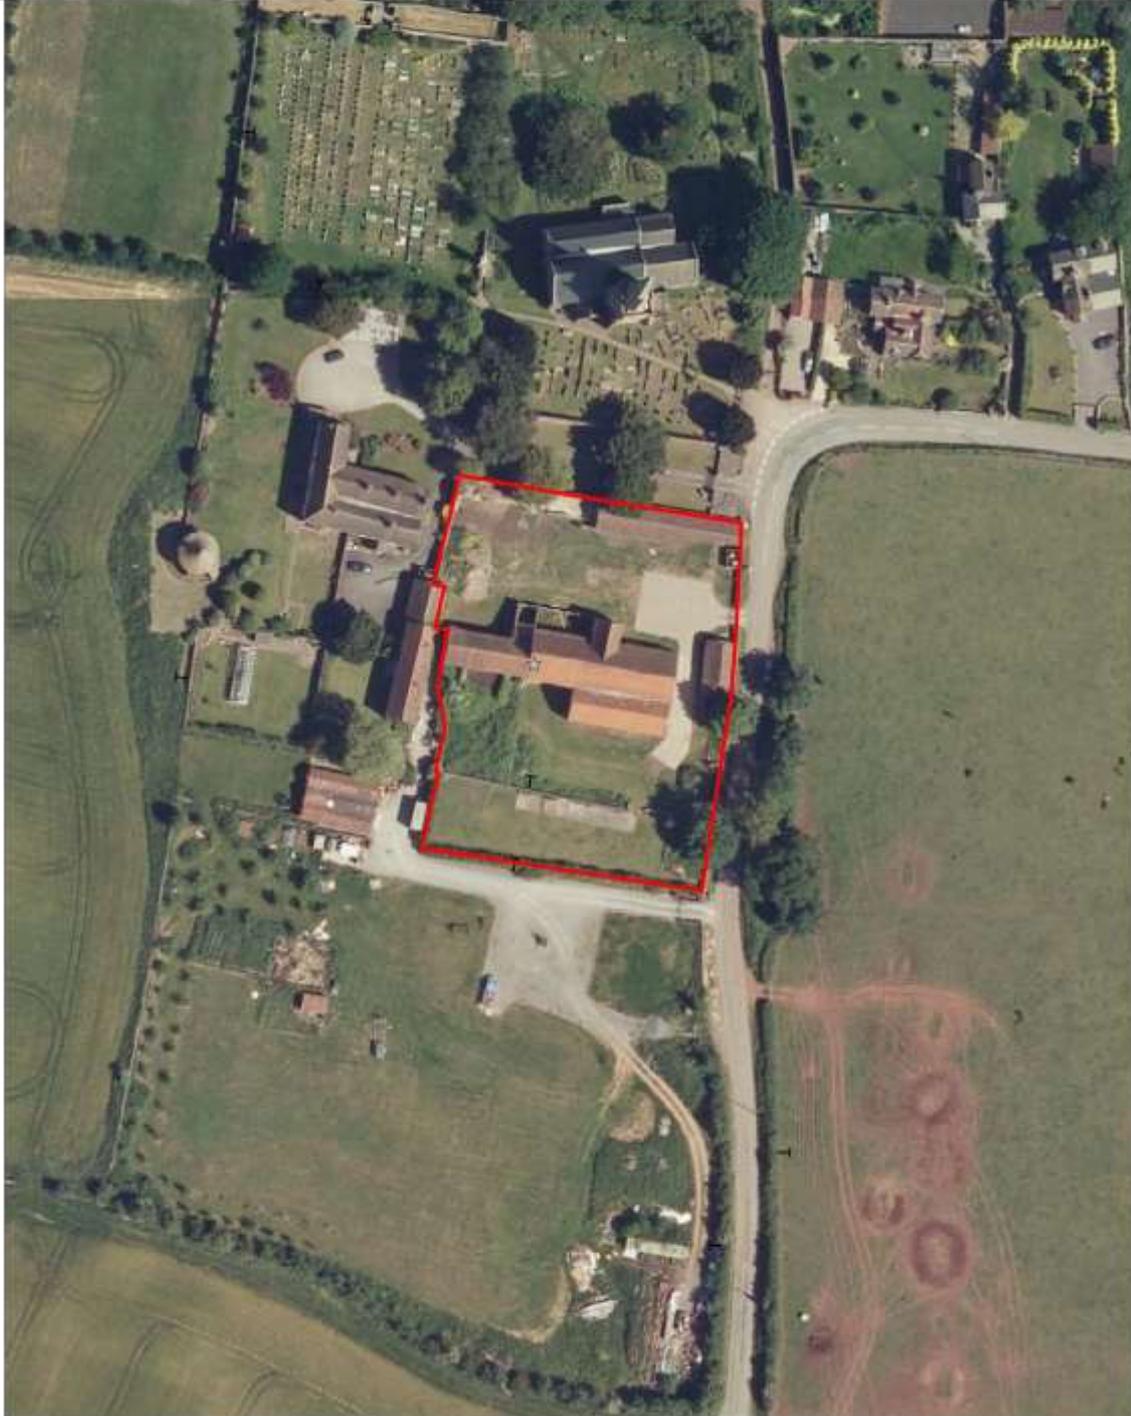
## 1.2 Location of the Barn and Site Plan

Please note: this plan is an indication only of Council ownership.  
Definitive boundaries should be obtained from the relevant Deed Packet
